# Geophysical Investigation of Cluster 11, Edgewood Area, Aberdeen Proving Ground, Maryland

by Michael K. Sharp, Janet E. Simms, Landris T. Lee, Jr., Jerry L. Burgess

U.S. Army Corps of Engineers Waterways Experiment Station 3909 Halls Ferry Road Vicksburg, MS 39180-6199

Final report

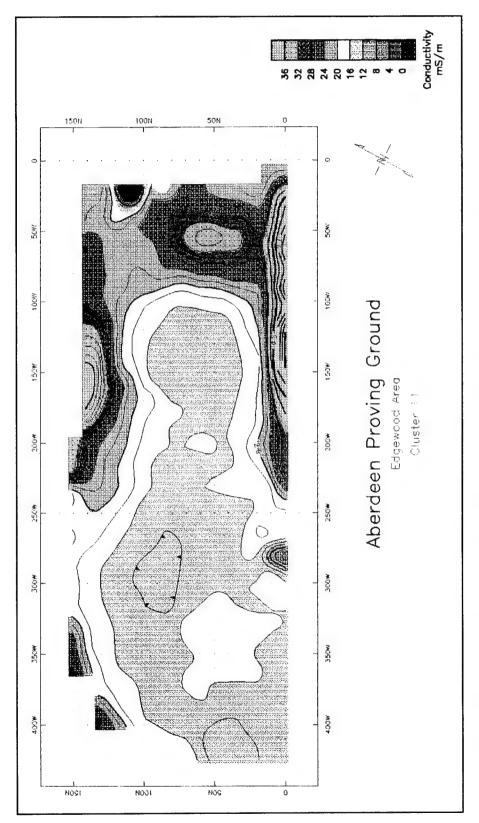
Figure 11. EM-31 conductivity survey for Site 1. Contours are 2 mS/m. Station intervals are 10 ft (3 m)

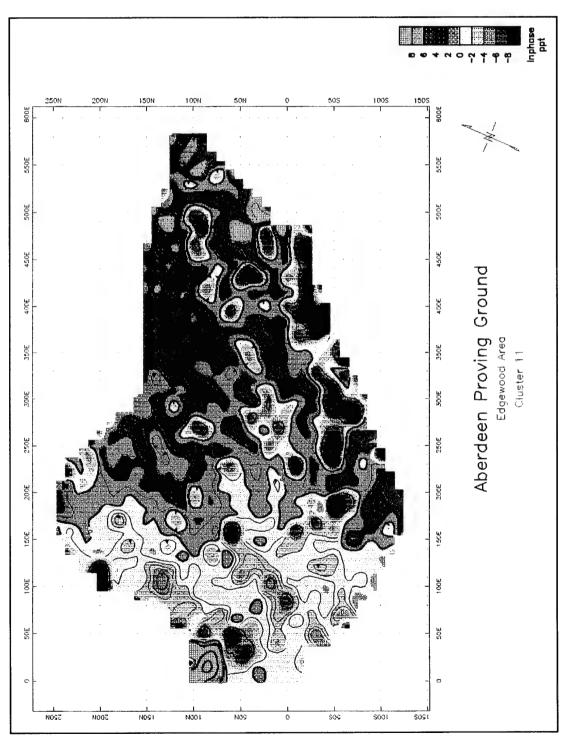
Figure 16. EM-31 inphase survey for Site 2. Contours are 1 ppt, and station intervals are 10 ft (3 m)

inphase survey are shown in Figure 16, with contours every 1 ppt. The results are exactly as stated for the conductivity survey. Although not as clear from the inphase survey as the conductivity, there is a linear trend in a northerly direction through the eastern section from 150E, 100S to 450E, 100N.

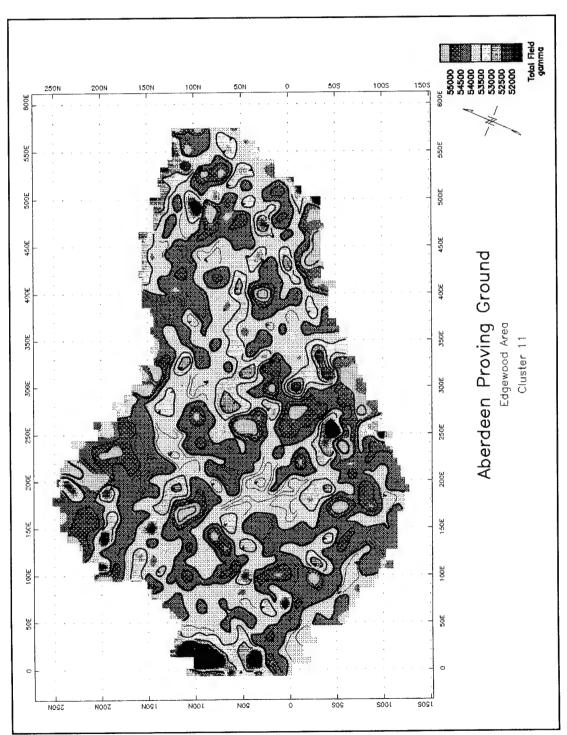
Based on the findings from all the surveys conducted at Site 2, the interpretation that this area is almost certainly a part of a landfill area can be drawn. The high conductivity values and large number of magnetic anomalies would tend to support this conclusion.

Figure 17. Magnetic total field survey for Site 2. Contours are 250 gammas, and station intervals are 10 ft (3 m)

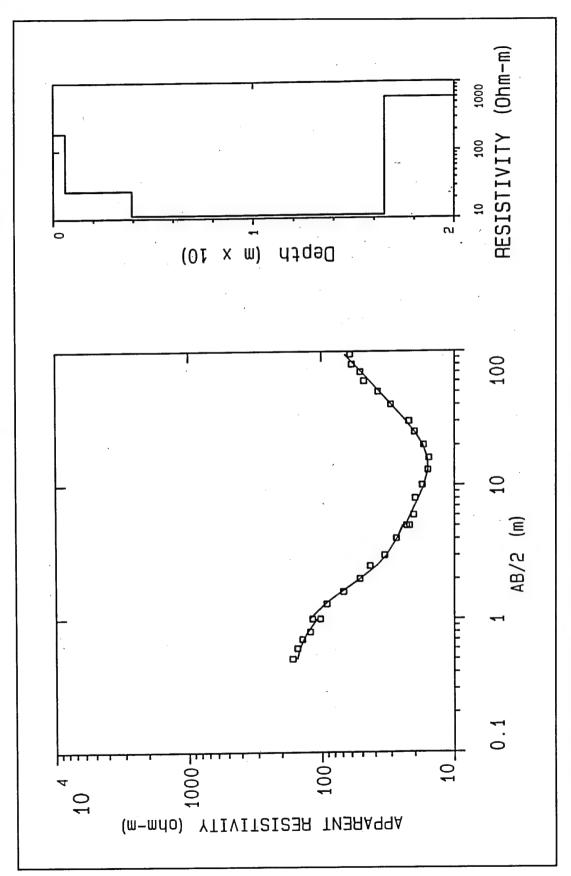
Figure 26. Resistivity sounding line 2 at Site 2, showing inversion curve (left) and interpreted layers (right)

Electrical resistivity line 2 was run along grid line 80N, and centered at location 300E. The line was 200 m in length (100 m in each direction from the center point). The sounding curve and resulting interpreted model for this line are shown in Figure 26. The model reveals four layers; layer one with a thickness of 0.58 m and an apparent resistivity of 182 ohm-m, layer two with a thickness of 3.3 m and apparent resistivity of 26 ohm-m, layer three with a thickness of 12.5 m and apparent resistivity of 11 ohm-m and layer four with an unknown thickness and apparent resistivity of 597 ohm-m. Performing an equivalence analysis of this data set reveals the range of resistivities and computed layer thicknesses that would also be valid models. This information is shown in Figure 27. For layer one the resistivities could range from 162 to

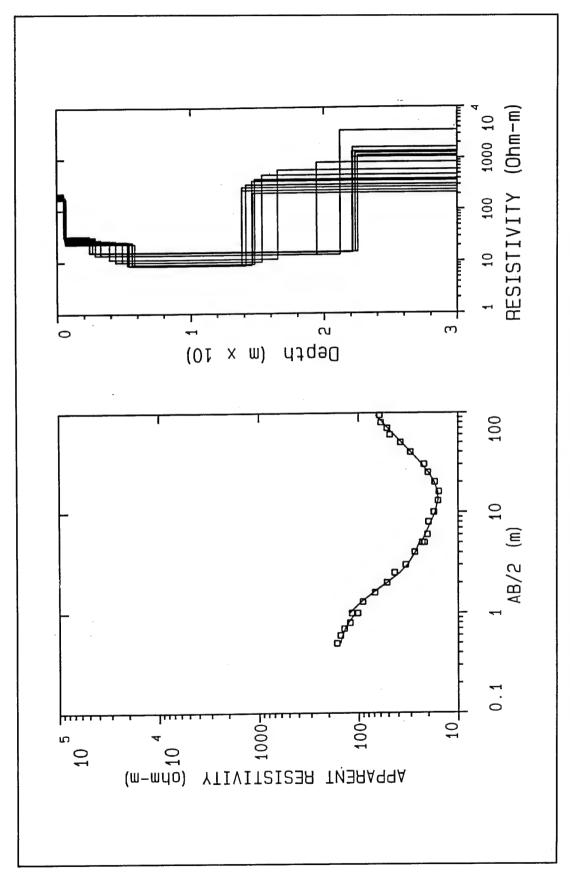
Figure 27. Inversion curve (left) and equivalence models (right) for resistivity sounding line 2 at Site 2

215 ohm-m with a layer thickness of 0.50 to 0.66 m. For layer two the resistivities could range from 22 to 32 ohm-m with a layer thickness of 1.9 to 5.2 m. For layer three the resistivities could range from 8 to 15 ohm-m with a layer thickness of 8.5 to 20.0 m. For layer four the resistivities could range from 213 to 3500 ohm-m with an undetermined thickness. This information reveals that the resistivities for layers one, two and three and the thickness of layer one are modeled extremely well. The thicknesses of layers two and three are not as accurately modeled. The depth to the top of layer two (bottom of layer one) could range from 2.5 to 5.8 m and the depth to the top of layer three (bottom of layer two) could range from 14 to 22.5 m. The inversion program also poorly modeled the resistivity of the fourth layer. This is due to the fact that insufficient data was acquired at deeper depths to accurately define this layer.

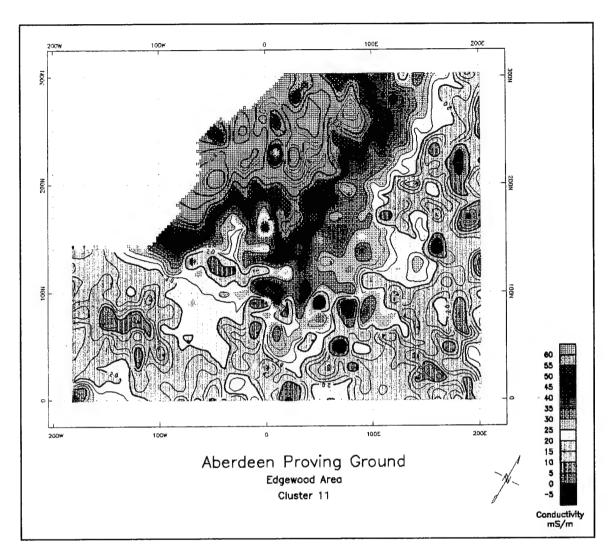
Figure 28. EM-31 conductivity survey for Site 3. Contours are 2.5 mS/m, and station intervals are 10 ft (3 m)

Based on all the surveys performed in this area, the following interpretation can be made. The northwest corner of the grid is clearly more conductive than the rest of the site and contains many metallic anomalies. There was some amount of surface trash observed in this area which contributes to the observed readings. This area slopes toward a nearby creek draining the area, which may also contribute to the higher conductivity values. However there is clearly a large amount of metallic material in this area that must be located beneath the surface. There is also a very strong possibility that this area might be a continuation of the linear trend observed at Site 2. The other significant anomalous area is that at location 130W, 60N. This area appeared in every test and is not explained by surface features. The anomalies detected at this area are shown in Table 2.

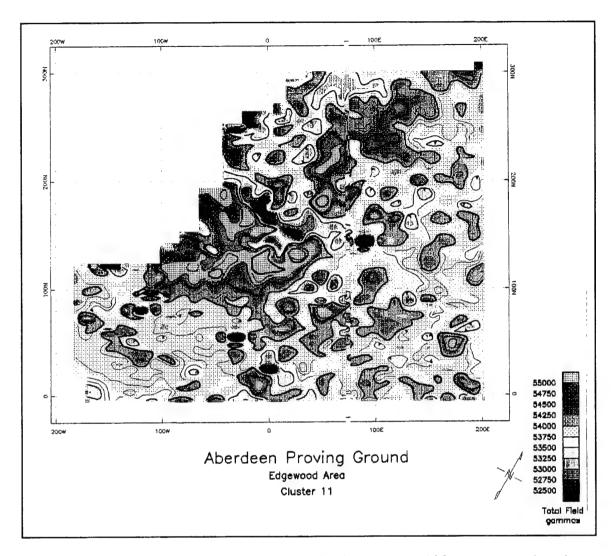
Figure 30. Magnetic total field survey for Site 3. Contours are 100 gammas, and station intervals are 10 ft (3 m)

The results of the magnetometer survey are shown in Figures 30 and 31. Figure 30 is a plot of the total field survey results with contours displayed every 100 gammas. Background readings for this area are approximately 53,750 gammas. The plot reveals several anomalous areas which are small isolated spots due to surface trash. The significant anomalies are located at 130W, 60N and from 0W to 100W extending from 100N to 200N. The results of the magnetic gradient survey are shown in Figure 31, with contours every 100 gammas/m. Here again the significant anomalies are the same as discussed for the total field survey.

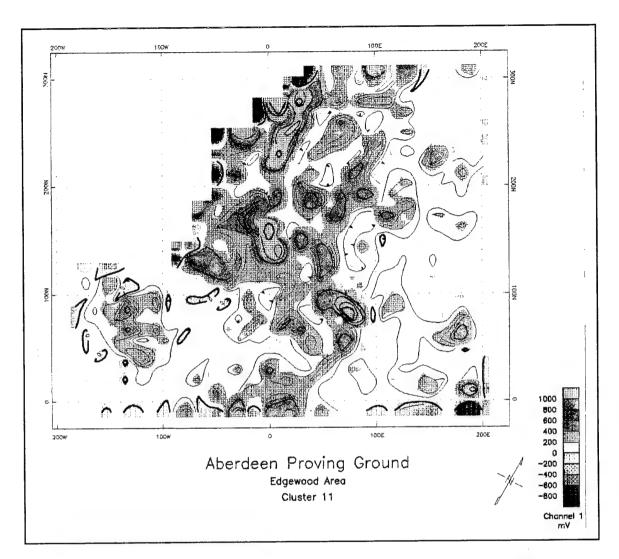
Figure 32. EM-61 bottom coil survey for Site 3. Contours are 100 mV, and station intervals are 10 ft (3 m)

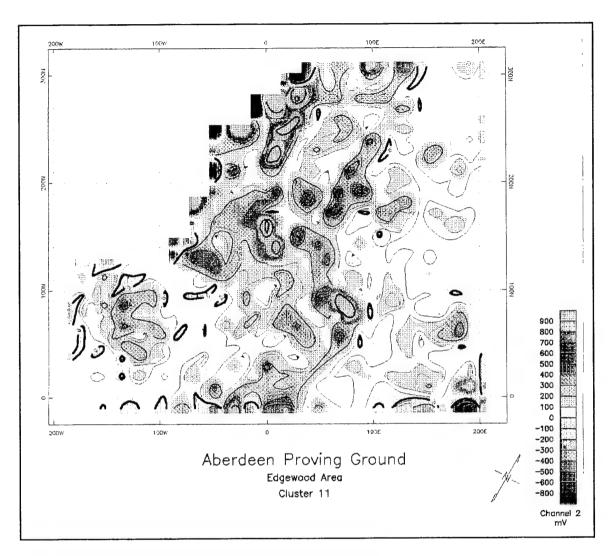
Figure 33. EM-61 top coil survey for Site 3. Contours are 100 mV, and station intervals are 10 ft (3 m)  $^{\circ}$

difference between the coils with contours every 20 mV. All three plots illustrate the same anomalous areas as discussed previously, namely at location 130W, 60N and the northwest corner of the grid.

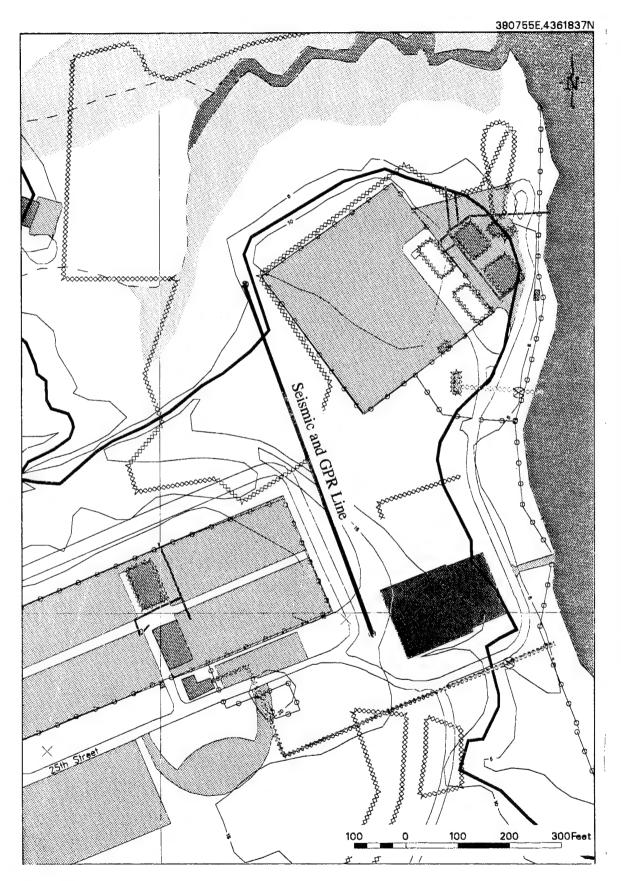
To aid in the geological interpretation, seismic reflection and GPR surveys were performed at the site. The location of the seismic reflection line is shown in Figure 35. A detailed explanation of the test procedures and results can be found in Appendix A. The line was 206 m long and extended through Site 3 and parallel to Site 6 (located west of Site 6 on the west side of the earthen berm). The results of the survey are shown in Figure 36 (Appendix A

Figure 35. Seismic reflection line 200 and GPR survey lines at Site 3. Metric scale: 1 cm = 25 m

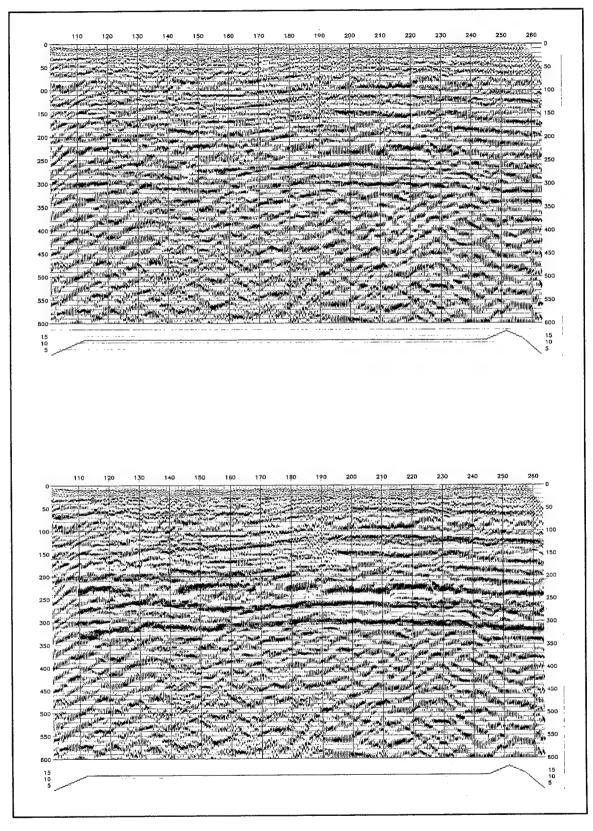
Figure 36. Seismic reflection line 200 showing depth section (top) and layer interpreted depth section (bottom). Horizontal and vertical intervals are 10 ft (3 m)

Aside from the general dip of the layers, there are also thinning of certain layers and formation of a channel-like feature. The results indicate a pinching out of a thin bed within the Cretaceous and above the interpreted Canal Creek aquifer at a depth of 15 m near station 230 which is in agreement with a possible sand lens noted on the stratigraphic cross section. Also, the Canal Creek aquifer itself shows apparent thinning from a typical 15 m thickness on the south end of the line down to a minimum thickness of 4.5-6 m near station 210. North of this area, there is downwarping and apparent thickening of the Canal Creek reflection. The overlying reflections continue across without significant downwarping, therefore this is not a general 'statics' problem. This has the appearance of a channel. It is important to note that several of the beds appear to thin at the southern end of the line and trend toward the north. The appearance of a channel is supported by two cross sections in the area based on data from monitoring wells. The two sections are shown in Figures 37 and 38 (see Figure 3 for section locations). As seen on cross section A-A' and B-B' the axial minima of this channel is near WBR-35 and WBR-43. Based on borehole and geophysical constraints, this channel may trend to the northwest/southeast.

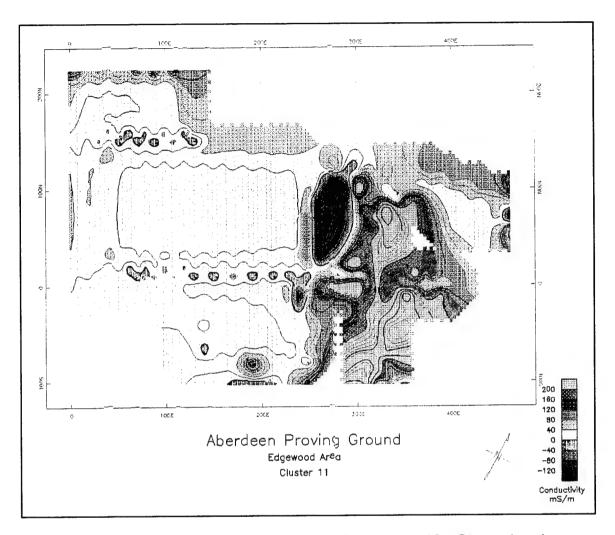
The Site 4 grid layout and surface features were shown in Figure 8. The results of the EM-31 survey are shown in Figures 42 and 43. Figure 42 shows the results of the conductivity survey with contours every 20 mS/m. The plot is relatively clear of anomalies except for the area in and around the buildings. In the area away from the buildings the only anomalies that occur are those associated with the fence (indicated around the edges of the plot). Although the buildings are affecting the area around them and effectively masking any anomalies nearby, there are indications of anomalies close to the buildings. Specifically, there is a linear northwest trending anomaly at location 240E from 20N to 100N. This may be an underground pipe associated with the nearby building. This pipe probably extends further south, in front of the next building. In addition, there is an anomalous area at location 140E, 40S. The cause of this anomaly is unknown. The high values around the western edge of the plot are associated with the chain link fence. The low at location 300E, 0N was due to construction equipment. The results of the inphase survey are shown in Figure 43 with contours every 2.5 ppt. The same features as discussed previously also apply to these data.

Figure 42. EM-31 conductivity survey for Site 4. Contours are 10 mS/m, and station intervals are 10 ft (3 m)

feature located beside one of the buildings at location 240E from 20N to 100N. The other anomalies unaccounted for by surface features occur at locations 140E, 40S; 230E, 0-20S; 240E, 10 -70N; and 440E, 105N. The causes of these anomalies are unknown. The anomalies detected at Site 4 are presented in Table 3.

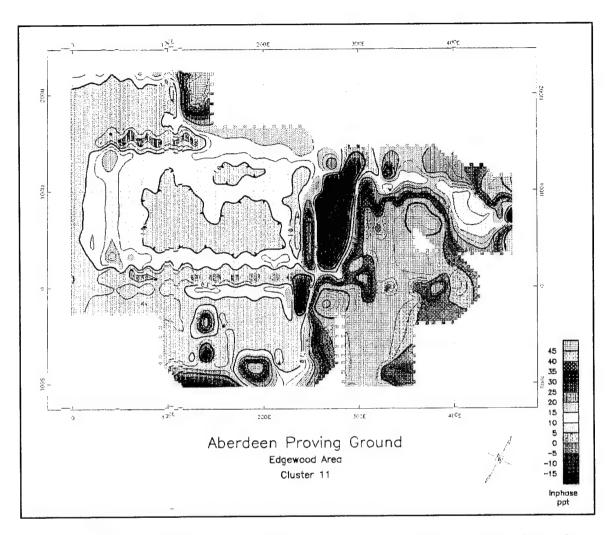
Figure 43. EM-31 inphase survey for Site 4. Contours are 2.5 ppt, and station intervals are 10 ft (3 m)

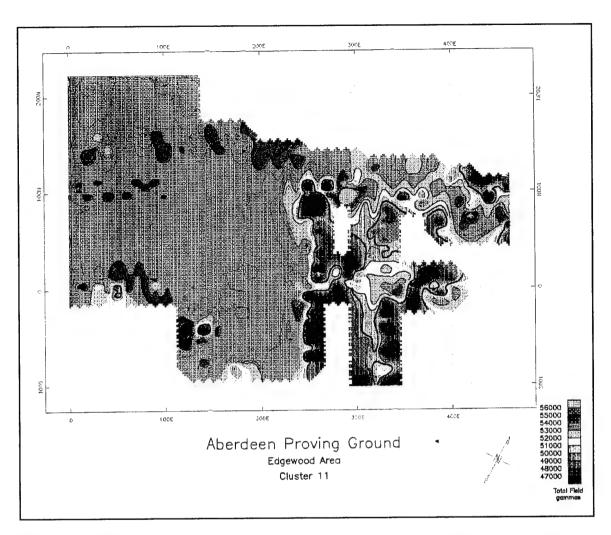
The results of the magnetometer survey are shown in Figures 44 and 45. Figure 44 shows the results of the total field survey with contours every 500 gammas. The only clear anomaly from this data, not associated with a surface feature, is that at location 140E,40S. The results of the magnetic gradient survey are shown in Figure 45 with contours every 200 gammas/m. The same anomalies detected in the total field survey are also indicated in this data.

Figure 44. Magnetic total field survey for Site 4. Contours are 250 gammas, and station intervals are 10 ft (3 m)

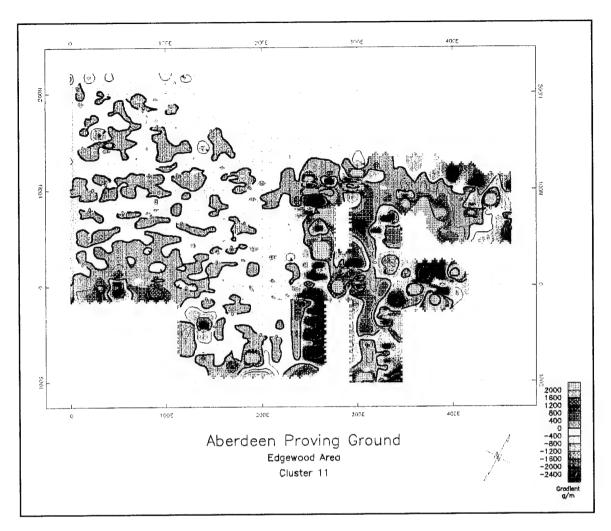
Figure 45. Magnetic gradient survey for Site 4. Contours are 200 gammas/m, and station intervals are 10 ft (3 m)

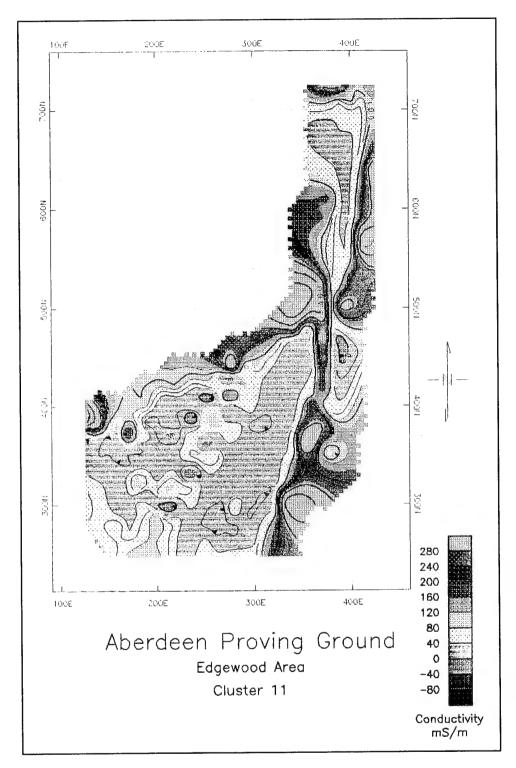
The Site 5 grid layout and surface features were shown in Figure 9. The results of the EM-31 survey are shown in Figures 46 and 47. Figure 46 shows the results of the conductivity survey with contours every 20 mS/m. The site contains many surface features evidenced in the data. The road running through the site is apparent in the data and trends northeast-southwest from location 200E,250N to 300E,480N. Monitoring well 3 appears at location 390E,500N and the small building just south of MW-3 at location 380E, 470N. The catch basin produces an anomaly at location 350E, 360N. Well WBR-33 and the tank located south of it in addition to a power pole all combine to produce the large anomaly at location 350E, 300N. The results of the inphase survey are shown in Figure 47 with contours every 2.5 ppt. The only apparent anomalies are from surface features.

Figure 46. EM-31 conductivity survey for Site 5. Contours are 10 mS/m, and station intervals are 10 ft (3 m)

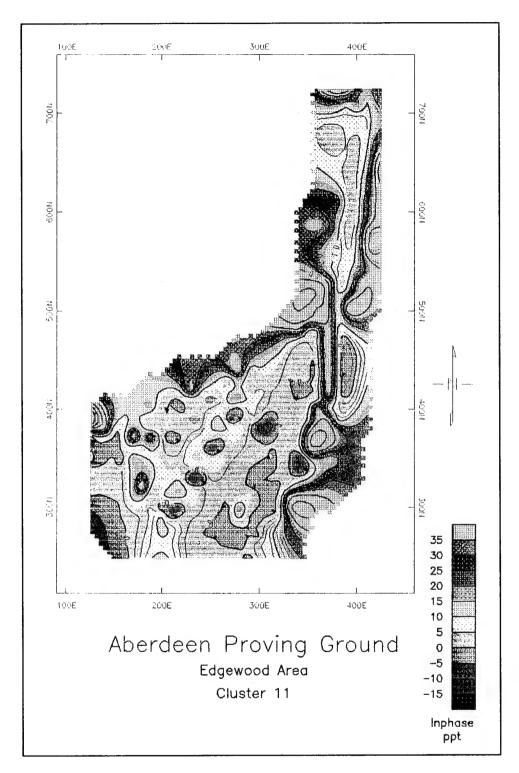
Figure 47. EM-31 inphase survey for Site 5. Contours are 2.5 ppt, and station intervals are 10 ft (3 m)

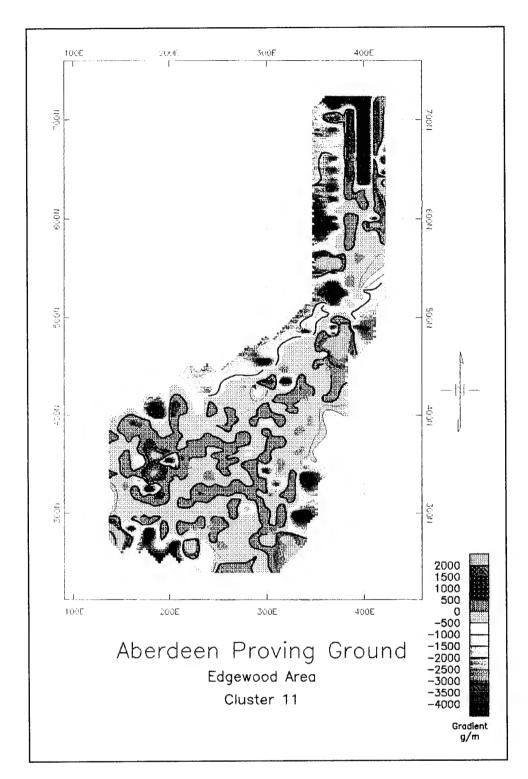
Figure 49. Magnetic gradient survey for Site 5. Contours are 250 gammas/m, and station intervals are 10 ft (3 m)

500 gammas. Figure 49 shows the results of the magnetic gradient survey with contours every 250 gammas/m. The anomalies are likely due to surface features.

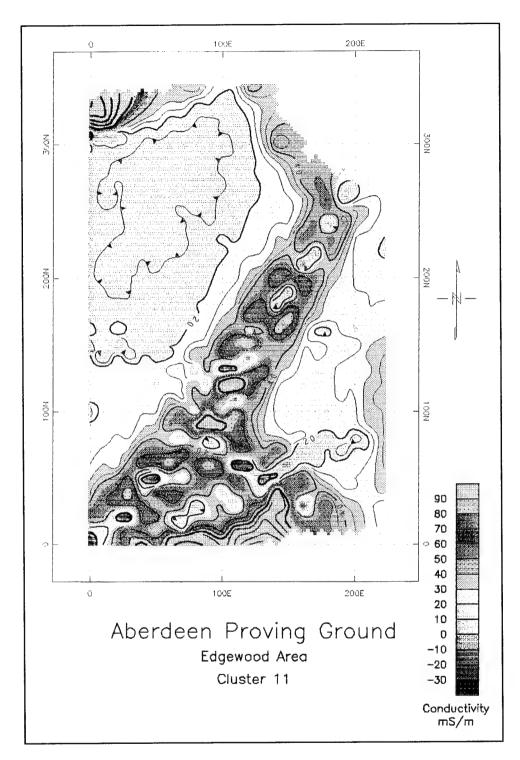
The Site 6 grid layout and surface features were shown in Figure 10. The results of the EM-31 survey are shown in Figures 50 and 51. Figure 50 shows the results of the conductivity survey, with contours every 10 mS/m. An anomalous zone with a northeast-southwest trend extends across the site. No surface feature is associated with this very large anomaly. The only other anomalous areas in the survey are at locations 20E,320N (associated with the fence), and at location 100E,0N (associated with the abandoned building). The results of the inphase survey are shown in Figure 51, with contours every 1 ppt. The same results determined from the conductivity survey are apparent for the inphase survey.

Figure 50. EM-31 conductivity survey for Site 6. Contours are 5 mS/m, and station intervals are 10 ft (3 m)

Based on the surveys conducted in this area, the following conclusions can be drawn. One anomaly that is not associated with a known surface feature is the large northeast-southwest trending anomaly. This anomaly is both a conductive and magnetic (based on the EM-31) anomaly. However, the results from the magnetometer survey did not indicate a very strong anomaly which would be indicative of ferrous material. The EM-61 did show a very large response to the anomaly since it responds well to metallic and non-metallic material. The possibilities for the cause of the anomaly would be a trench or drainage system containing slightly metallic rocks, or possibly a non-ferrous pipe. A summary of anomalies detected at this site is shown in Table 5.

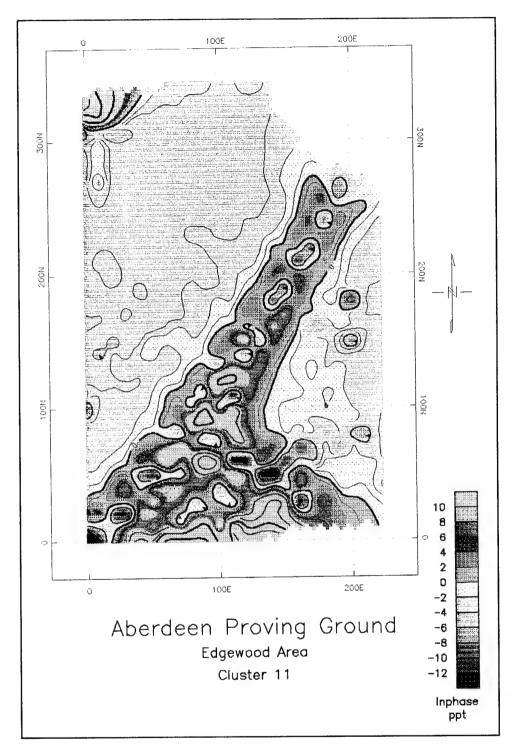
Figure 51. EM-31 inphase survey for Site 6. Contours are 1 ppt, and station intervals are 10 ft (3 m)

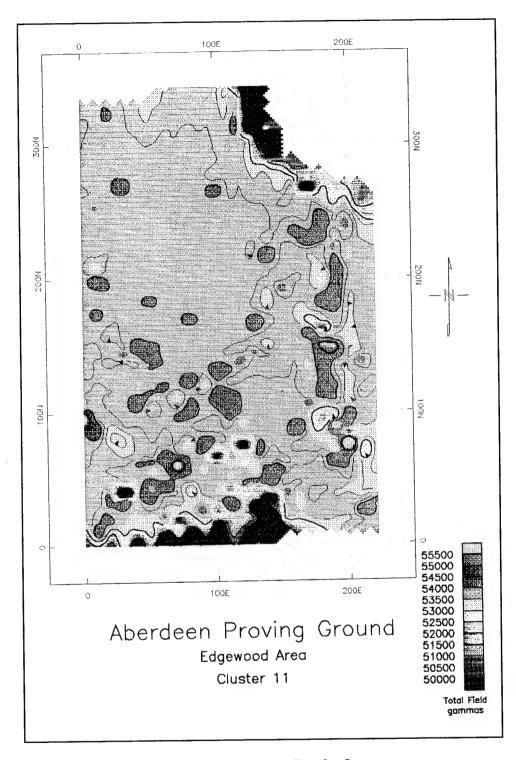
The results of the magnetic survey are shown in Figures 52 and 53. Figure 52 shows the results of the total field survey with contours every 250 gammas. Although not as apparent, the same northeast-southwest trending anomaly is detected in the data. In addition to this, the paved road produces a signature trending north-south at location 190E. The magnetic effects of the building are detected in the southern portion of the plot and the chain

Figure 52. Magnetic total field survey for Site 6. Contours are 250 gammas, and station intervals are 10 ft (3 m)

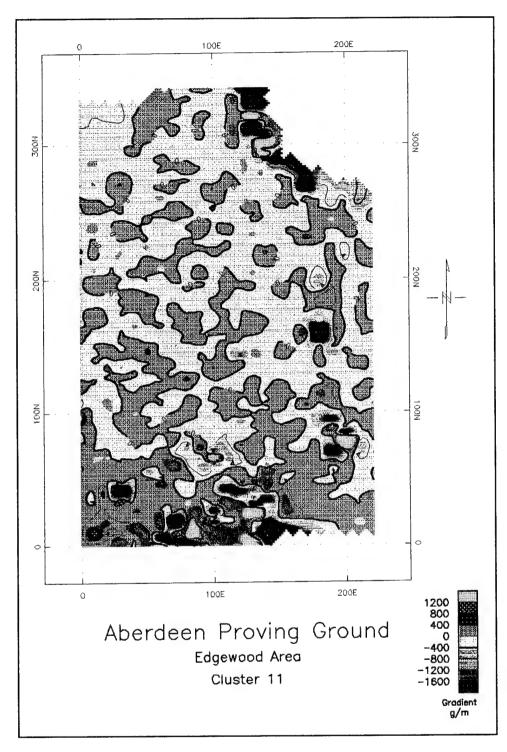
Figure 53. Magnetic gradient survey for Site 6. Contours are 200 gammas/m, and station intervals are 10 ft (3 m)

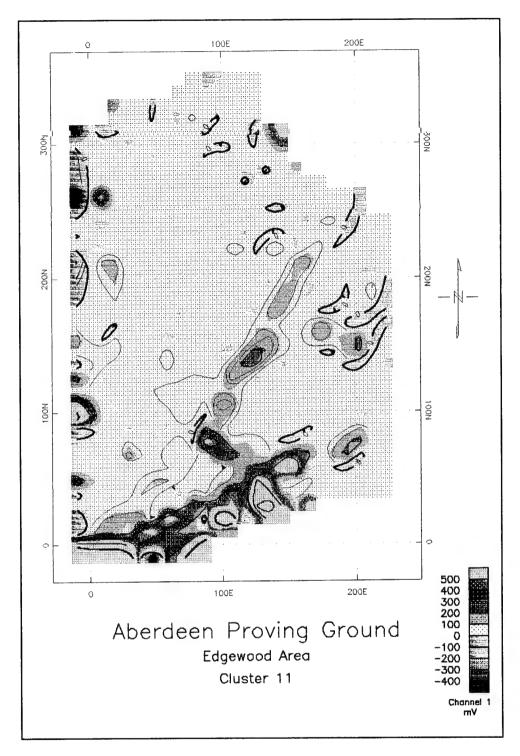
The results of the EM-61 survey are shown in Figures 54 through 56. Figure 54 is a plot of the results from the bottom coil of the instrument, with contours every 50 mV. The northeast-southwest trending anomaly is apparent, as is the building and wells that appear in the southern portion of the plot. A plot of the results from the top coil of the instrument is shown in Figure 55 with contours every 50 mV. The same anomalies are apparent in this data as discussed for the bottom coil. Figure 56 is a plot of the difference between the two coils. This figure shows the anomalies extremely well. The building and wells are apparent in the southern portion of the plot, and the northeast-southwest trending anomaly is also clearly apparent. Also apparent is an anomaly at location 190E,160N which is associated with a concrete drainage structure passing beneath the paved road. This anomaly can also be seen in Figures 50 through 55.

Figure 54. EM-61 bottom coil survey for Site 6. Contours are 50 mV, and station intervals are 10 ft (3 m)

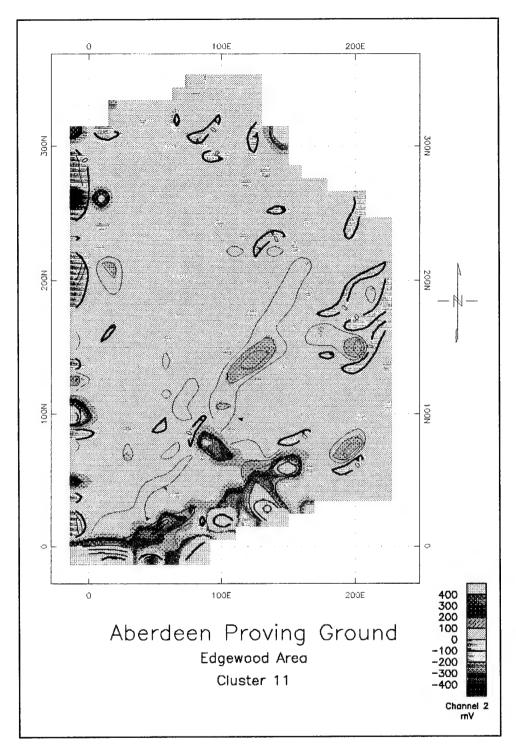
Figure 55. EM-61 top coil survey for Site 6. Contours are 50 mV, and station intervals are 10 ft (3 m)

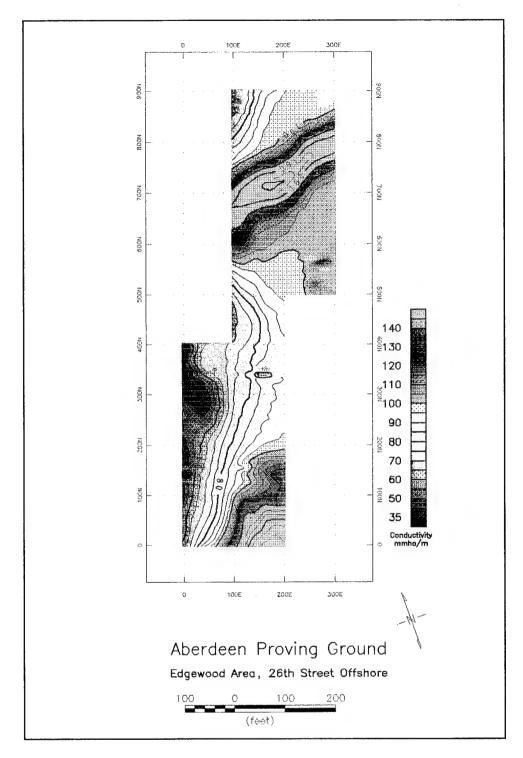
The layout of the grid for the offshore survey was shown in Figure 2. The results of the survey for offshore Site 1 are shown in Figures 57 through 59. Figure 57 shows the results of the EM-31 conductivity survey with contours every 5 mS/m. The effects of the concrete WWII pier can be seen in the southern portion of the plot. There is a general trend of increasing conductivity values away from the shore. There is also a large area of high conductivities in a linear feature trending nearly east-west from location 100E,660N to location 300E, 800N. The results of the inphase survey are shown in Figure 58 with contours every 0.5 ppt. The same features are apparent in this data as previously discussed. The results of the magnetometer total field survey are shown in Figure 59 with contours every 20 gammas. These results do not show the linear trend associated with the EM-31 data. There are several smaller isolated anomalies scattered throughout the data. The anomalies detected at this site are presented in Table 6.

Based on the surveys performed at this site the following conclusions can be drawn. The cause of the linear trending anomaly located at offshore Site 1 is unknown. There are no onshore structures adjacent to this area that would account for the anomaly's occurrence (pipes, tracks, trash, etc.). Since there was no response from the magnetometer survey, the anomaly is not produced by ferrous material. The most likely cause of this feature is a channelized drainage system, or a non-ferrous structure. The two anomalies that appear in the offshore Site 2 area are also unknown in origin. The anomalous area near the power plant pier is most likely associated with the pier's construction or activity on and around the pier. The other anomalous area near location 1000N, is directly adjacent to the Site 2 area. This can be clearly seen in Figure 2. This area does not appear anomalous in the magnetometer survey, again implying that there is no ferrous material in this location. Since the land survey at Site 2 indicates the presence of fill like material, it is possible that this material may have entered into the offshore area as well. This area also serves as the recipient of drainage for the area associated with Sites 1, 2, and 3, which contributes to the large conductive anomaly.

Figure 57. EM-31 conductivity survey for Offshore Site 1. Contours are 5~mS/m, and station intervals are 10 ft (3 m)

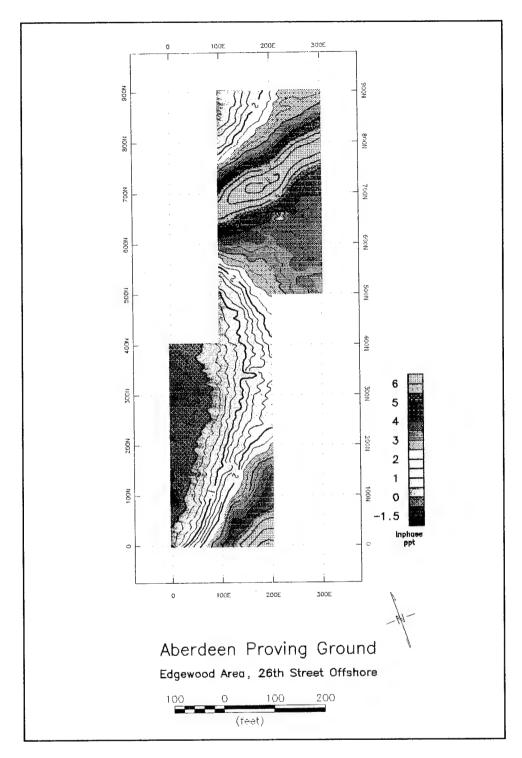
Figure 58. EM-31 inphase survey for Offshore Site 1. Contours are 0.5 ppt, and station intervals are 10 ft (3 m)

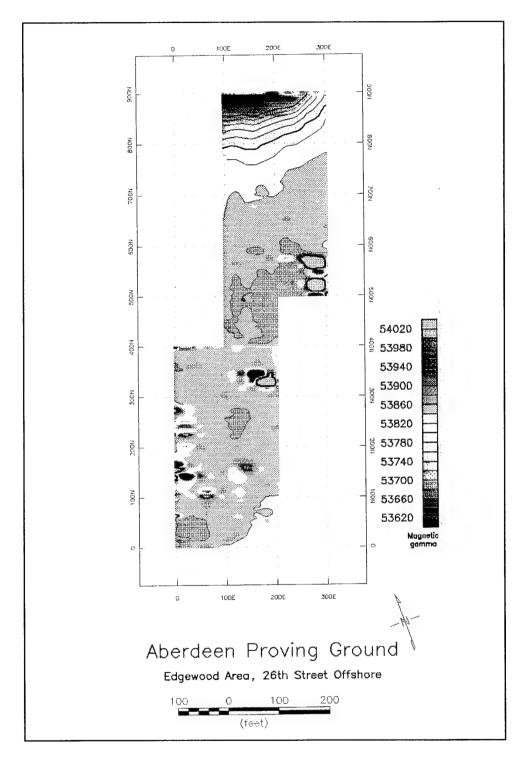
Figure 59. Magnetic total field survey for Offshore Site 1. Contours are 20 gammas, and station intervals are 10 ft (3 m)

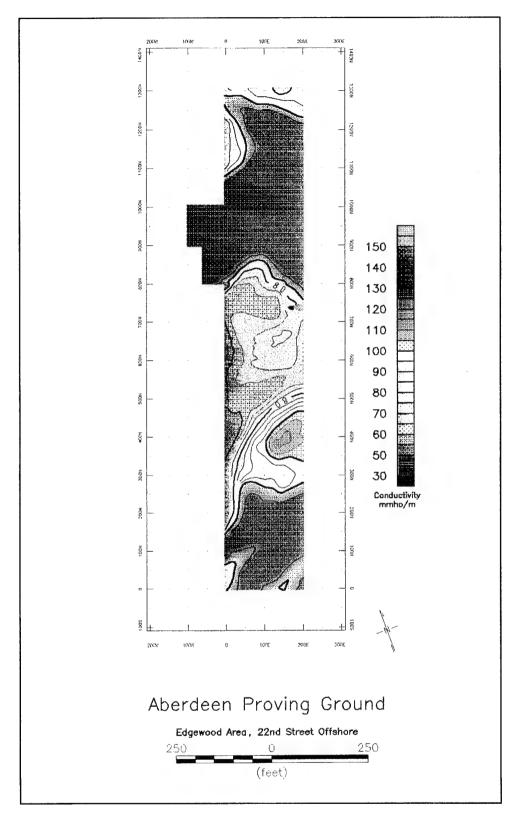
The results of the survey for offshore Site 2 are shown in Figures 60 through 62. Figure 60 shows the results of the EM-31 conductivity survey with contours every 5 mS/m. This plot shows two very large conductive anomalies. Both anomalies are trending nearly east-west. The first anomaly appears to be from location 0E,0N to location 200E,200N. The second anomaly from location 100W,900N to location 200E,1100N. This particular anomaly is directly associated with the fill that occurred at Site 2. The results of the inphase survey are shown in Figure 61. The same two linear trends as discussed previously are also apparent in this data. The results of the magnetic total field survey are shown in Figure 62 with contours every 50 gammas. The results show only two anomalous areas, that associated with a pier in the southern portion of the plot and that at location 100W,950N.

Figure 60. EM-31 conductivity survey for Offshore Site 2. Contours are 5 mS/m, and station intervals are 10 ft (3 m)

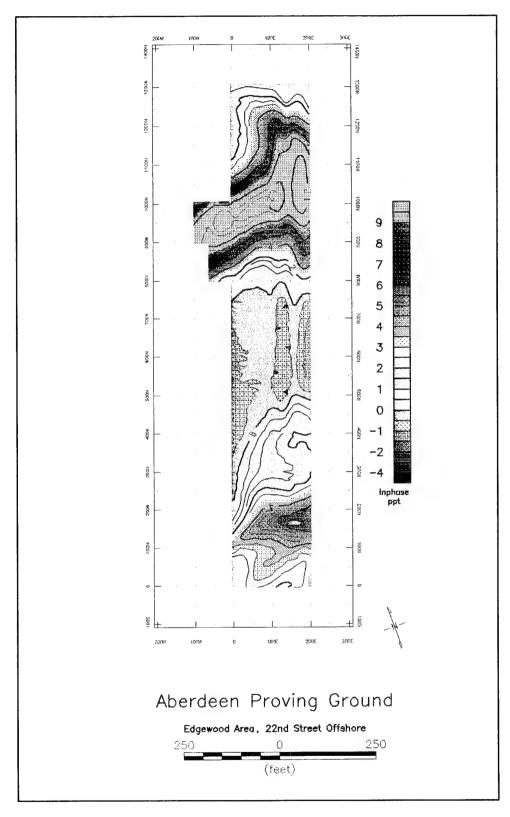
Figure 61. EM-31 inphase survey for Offshore Site 2. Contours are 0.5 ppt, and station intervals are 10 ft (3 m)

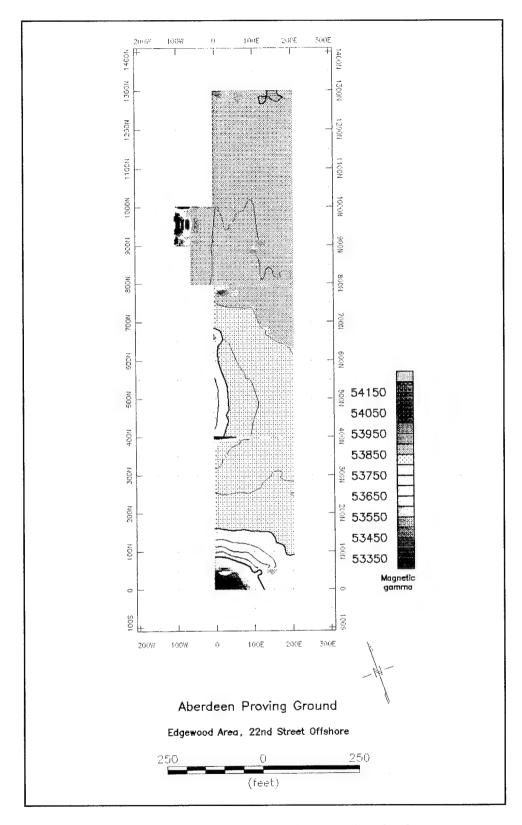
Figure 62. Magnetic total field survey for Offshore Site 2. Contours are 50 gammas, and station intervals are 10 ft (3 m)
